ACTA TECHNICA NAPOCENSIS

Series: Applied Mathematics, Mechanics, and Engineering  
Vol. 62, Issue II, June, 2019

## CORROSION TESTS OF AlMn1 / Ni201 BRAZED JOINT BY SALINE AND ACIDIC SPRAYING

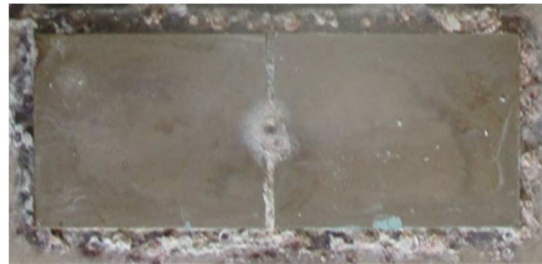
As shown in Figure 2, it is obvious that the saline solution was deposited around the brazing joint and at the distance between the Ni201 plates; corrosion attacked these areas the most. It is observed the formation of some crystals composed by salt and particles of AlMn1, deforming its surface, after 600 hours of spraying with saline solution. Noteworthy, the surface of nickel was very little attacked by saline corrosion.

Fig. 2 Brazed joint after 600 hours of salt spraying.

From this figure, however, it is not possible to determine the depth of corrosion and how much corrosion has entered inside the brazed joint. In order to achieve this goal, a cross-section metallography was made to this joint, Figure 3.

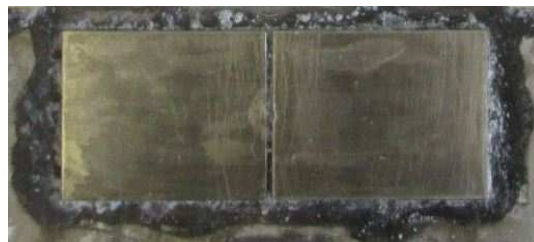
Fig. 4 Brazed joint after 600 hours of acetic acid spraying.

Respect the Figure 4, the acetic acid solution was concentrated around the brazed joint giving a black color, and after 600 hours there was a clear corrosion in the AlMn1 base material as a result of occupying a considerable area and depths; again, the nickel surface was not attacked by corrosion. In the case of saline corrosion, the salt had been deposited around the brazed joint forming many conglomerates composed by NaCl and aluminum oxides, some of which being quite difficult to remove. However, there is also the case of corrosion due to acetic acid because according to Figure 4, there are no high-rise areas, but the entire joint is surrounded by very low relief areas corresponding to some depths in the surface of the base material of AlMn1 (0.4 mm) made by the acid acetic.
