ACTA TECHNICA NAPOCENSIS

Series: Applied Mathematics, Mechanics, and Engineering
Vol. 66, Issue I, March, 2023

FAULT DIAGNOSTIC METHODS OF A CENTRIFUGAL PUMP

The objective of our work is to apply vibration analysis and oil analysis in the diagnosis of a pump bearing fault, located at the level of the atmospheric distillation unit (Skikda refinery), in order to optimize preventive maintenance, and to know the evolution of this defect.

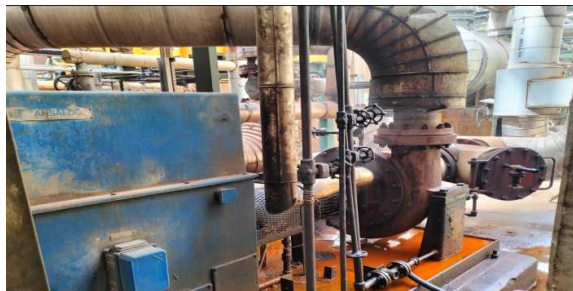
The 10MP15A is a circulation pump located at the level of the atmospheric distillation unit (Skikda refinery), it sucks the flow of circulation to make a better separation of gasoline.

Fig.1. Photo of the installation of our machine.

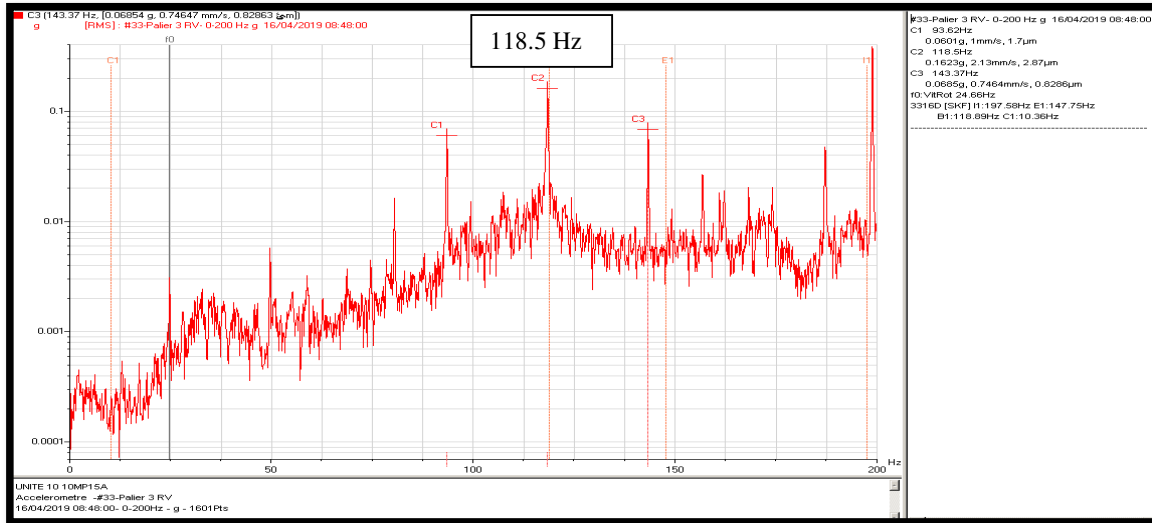
Fig.7. Spectrum of the point 3Rv (0 – 200) Hz.

Fig.8. Spectrum of the point 3Rv (0 – 2000) Hz

From the spectra above, we see a peak at the frequency of 118.5 Hz with amplitude of (0.16 g, 2.13 mm/s) and two Sidebands of Fr which is that of the ball defect Fb (BSF), we also observe Lines at the fault frequency (1xFb, 2xFb, 3xFb, etc.) reflecting periodic shocks.

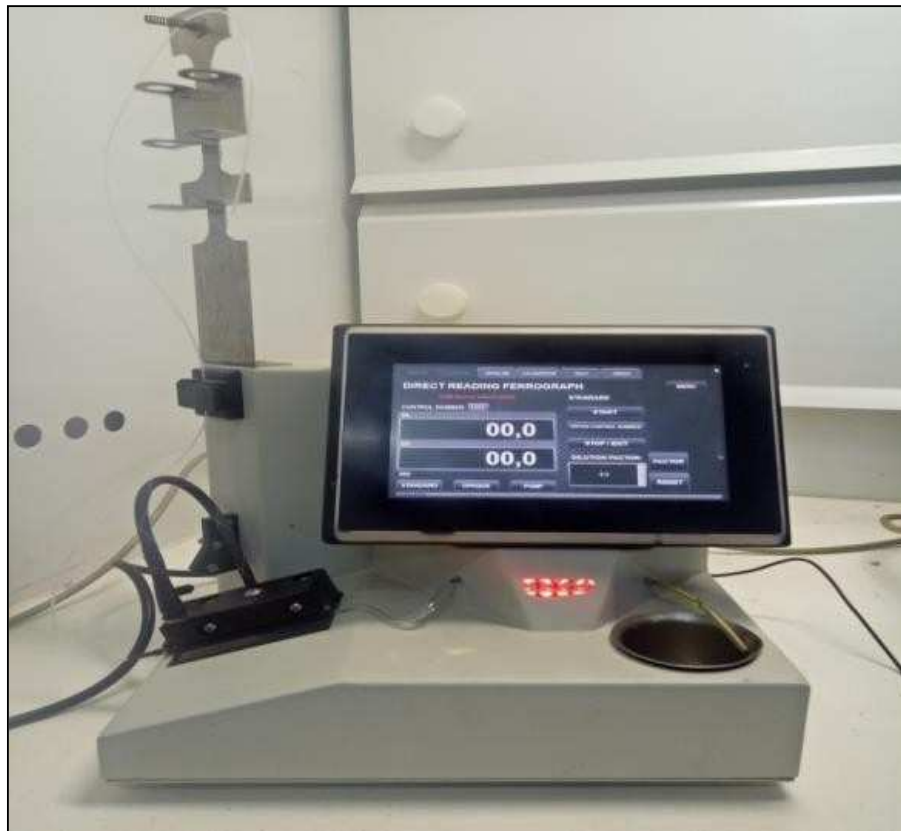
Is a trending instrument, providing readings that measure the amount of metal particles, large (DL) and small (DS) in a known oil sample.

Fig.9. Ferro graph DR.7.

We took an oil sample from the 1OMP15A pump, and tested the sample at the lab level with DR-7. [7]
