ACTA TECHNICA NAPOCENSIS

Vol. 55, Issue I, 2012

## EXPERIMENTAL RESEARCH REGARDING THE APPLICATION OF THE PREDICTIVE MAINTENANCE PROCEDURE WITHIN PAPER INDUSTRY

## 2. CASE STUDY: THE BLACK LYE PUMP OF REGENERATION BOILER

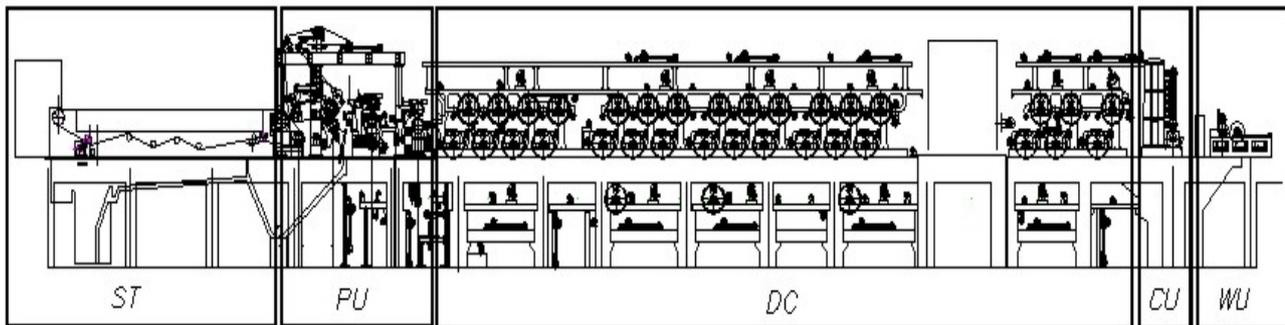
Fig.1. The basic scheme of the paper aggregate

ST - the table of the sieve; PU - press unit; DC - drying cylinders; CU – calender unit; WU – wrapping unit

- The raw material (the cellulose fiber + water + bounding agent + coloring agent+ filling materials) launched on the sieve and in the unit ST where the paper is formed as sheets and a big part of the water is being removed.

- The sequel in the press unit PU, for pressing the sheet paper, in order to remove the remaining water. (For this purpose the paper sheet is passing through the drying cylinders that are heated with steam).

- The calender unit CU that presses the paper in order to obtain a good gloss.

- The roller that ends the manufacturing process of the paper and the wrapping unit WU.

The utilized aggregate is composed by the following components, Figure1:

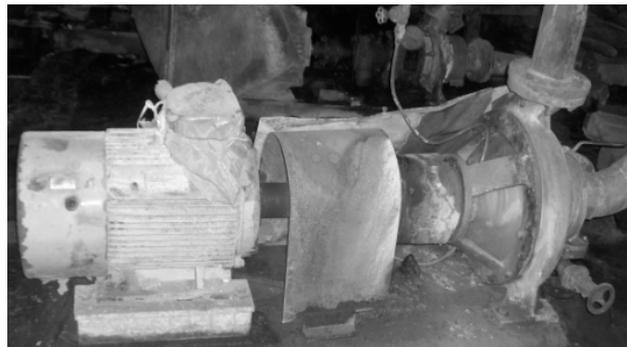
Fig. 2. Black lye pump

The black lye pump, illustrated in figure 2, is equipped with NU 312ECP bearing, on the rotor side, and a tow 6313NR bearing on the electric engine side [1]. The break down of the pump was caused mainly because of the deterioration of the 6313 NR bearing that is placed on the electric engine side.

- a wrong technical solution for fixing the axle of the pump on the bearings;
- a high level of vibrations caused by a wrong equilibrium of the rotor, sever misalignments, “soft foot” phenomena and high stresses of the tubes;
- sealing problems between the case of the pump and the axle of the pump, that leads to a lye penetration into the body of the pump.

- the radial roller bearing 6313 NR was replaced with two radial-axial roller bearings assembled in set from 7313 BECBP series;
- the dynamic balancing of the rotor was made for a relative velocity of 1500 rot/min;
- the soft consolidation between the case of the pump and its axle was replaced with a mechanical consolidation. For this purpose, the wear sleeve was taken out and the axle of the pump was modified in order to realize the optimal assembly of the mechanical consolidation;
- the manufacturing of the base plate of the pump has been made in one fixing direction.

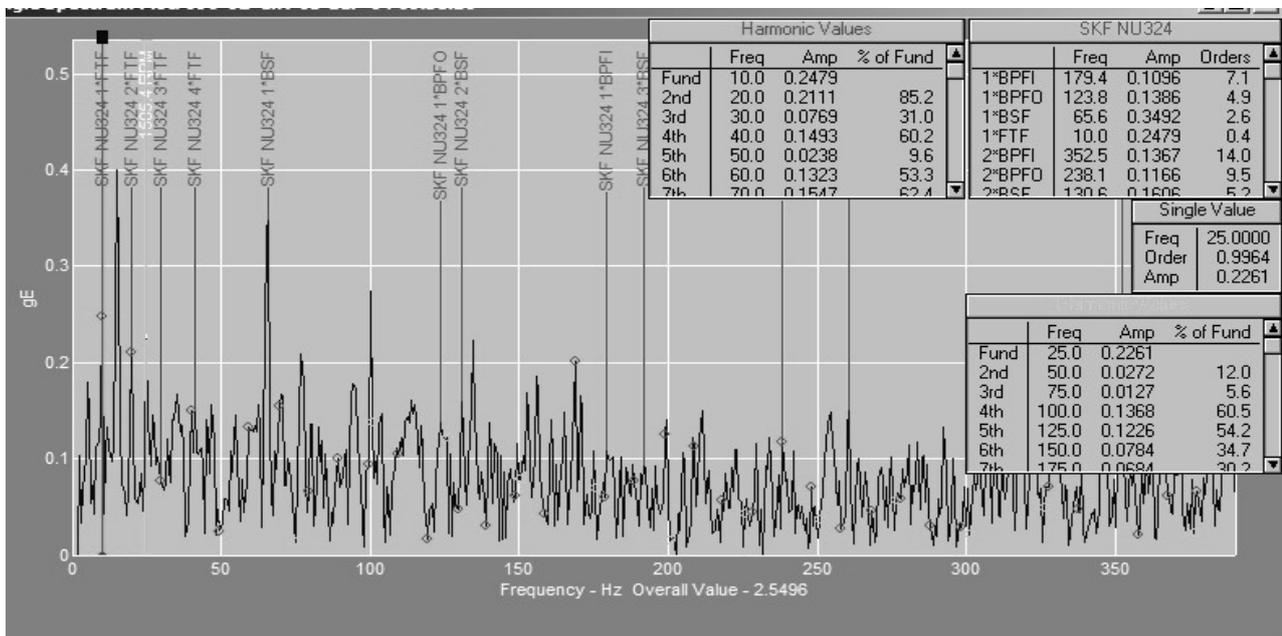
Fig. 3. The diagram of the evolution of the horizontal vibrations of the pump

In figure 3 is presented the evolution diagram of the horizontal vibrations period at one of the aggregate's pump.

As it can be observed from figure 3, the amplitudes started to be increased suddenly. After solutions that were applied, we

noticed that these amplitudes were finally brought back to the normal limits.

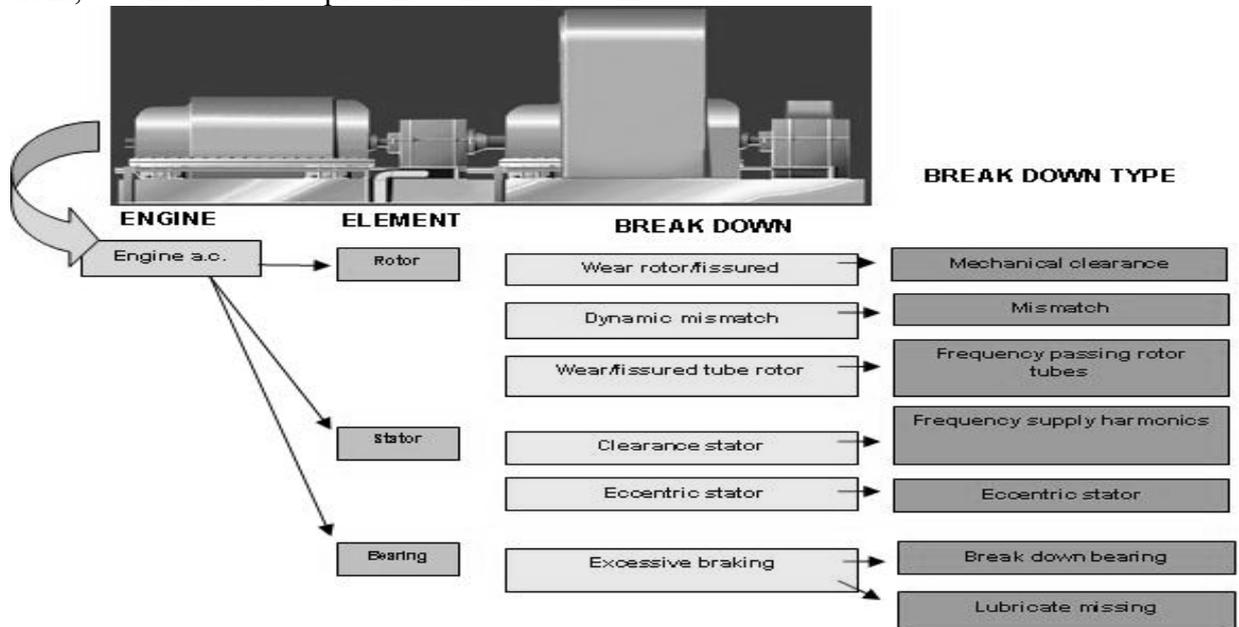
Fig. 4. Possible damages of the electric engine

The results obtained in the made research revealed the fact that the unexpected break downs of the pump electric engine were caused by the damages of the electric engine

components, such as the rotor, the stator or the bearings (figure 4).

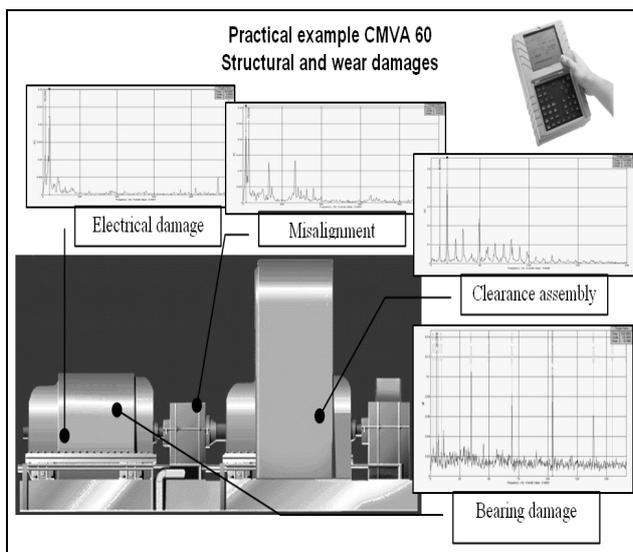
Fig. 5. Structural and wear damages

The maximum vibrations are caused by the misalignments during disassembling process and not by the prominent vibrations from the electrical damages, figure 5.

The bearings damages leads to vibrations with high frequency and variable amplitudes.

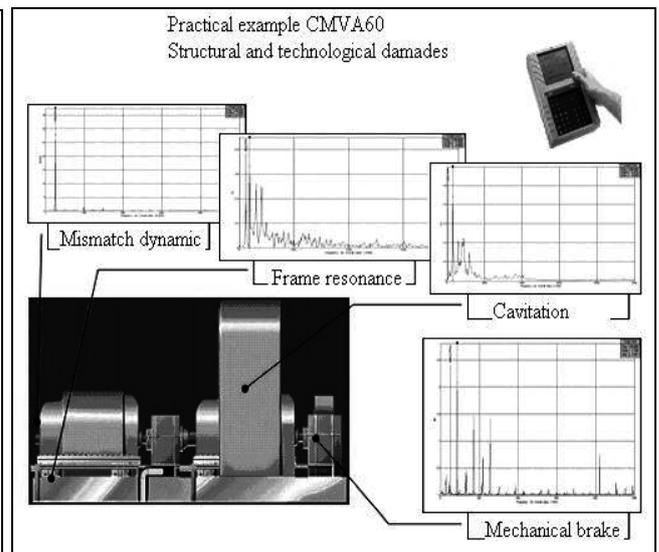
Fig. 6. Structural and technological damages

As illustrated in figure 6, it is possible to observe the fact that the machine frame resonance caused by the dynamic disequilibrium has the auto-amortization tendency.
