ACTA TECHNICA NAPOCENSIS

Series: Applied Mathematics, Mechanics, and Engineering
Vol. 58, Issue I, March, 2015

EXPERIMENTAL STUDY OF PASSENGER VEHICLE VIBRATIONAL BEHAVIOR IN ACCORDANCE WITH ITS MAINTENANCE

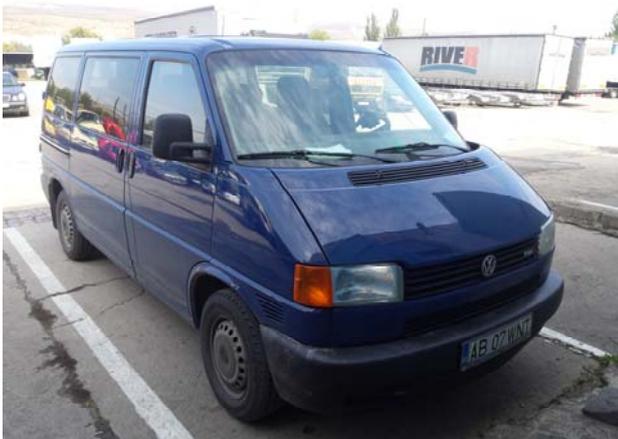
To highlight the vibrator response of a transport means, it was experimentally determined the vibrational behaviour of Volkswagen Caravelle vehicle, in the normal state, which has the following technical characteristics (as per registration certificate):

- manufacturing year: 2002;
- registration number: AB 07 WNT;
- number of seats: 8+1;
- power source: Diesel;
- maximum mass: 2800 kg;
- power: 75 kW;
- engine capacity: 2461 cm³;
- total running: 428988 km.

Fig. 1. Vehicle with AB 07 WNT registration number.

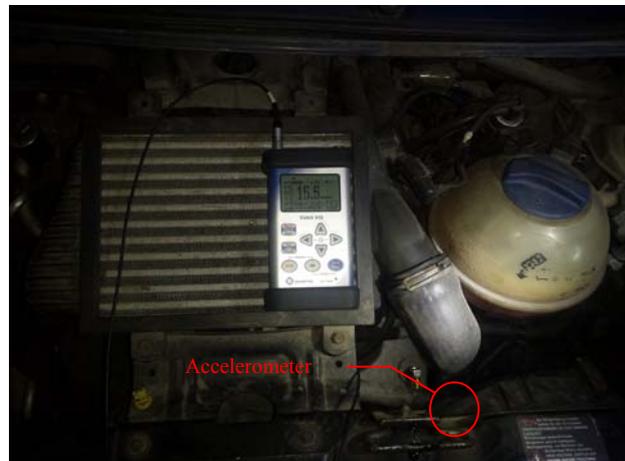
Vibration measurement mode, in the first measurement point, P1, is given in Figure 2.

Fig. 2. Location vibration measuring system for P1 measurement point.

According to Figure 2, the measurement axes of vibrations have the following correspondence with accelerometer measuring channels:

- Oz axis measurement for channel 1 - Ch1;
- Oy axis measurement for channel 2 – Ch2;
- Ox axis measurement for channel 3– Ch3.

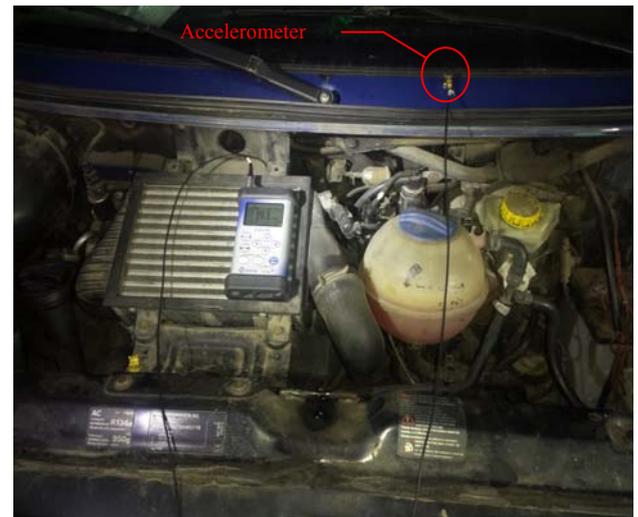
Vibration measurement mode, in the second measurement point, P2, is illustrated in Figure 5.

Fig. 5. Location vibration measuring system for P2 measurement point.

According to Figure 5, the measurement axes of vibrations have the following correspondence with accelerometer measuring channels:

- Oz axis measurement for channel 1 - Ch1;
- Oy axis measurement for channel 2 - Ch2;
- Ox axis measurement for channel 3 - Ch3.

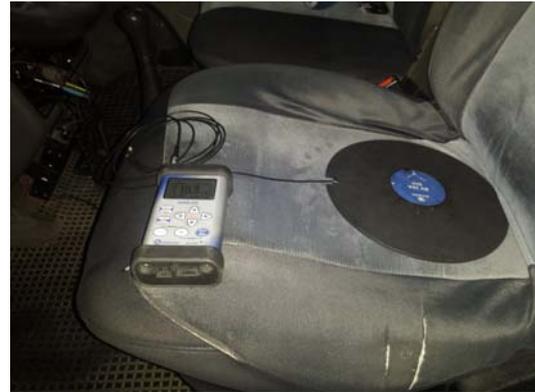
Vibration measurement mode, in the third measurement point, P3, is illustrated in Figure 8. According to this figure, the measurement axes of vibrations have the following correspondence with accelerometer measuring channels:

- Ox axis measurement for channel 1 - Ch1;
- Oy axis measurement for channel 2 - Ch2;
- Oz axis measurement for channel 3 - Ch3.

Fig. 8. Location vibration measuring system for P3 measurement point.

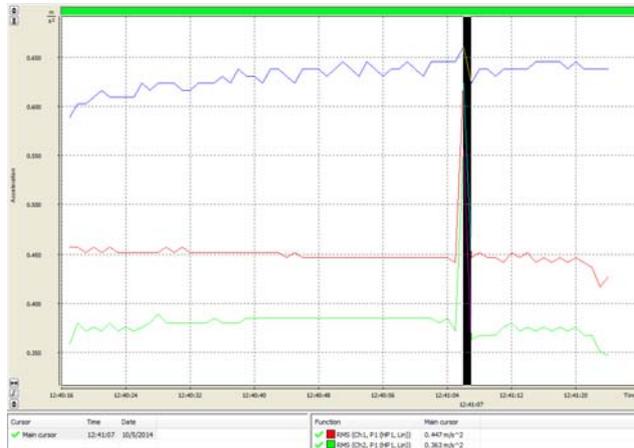
For example, the maximum RMS acceleration along the Oz vertical direction is by 641.95 mm/s^2 . This is confirmed by the oscillogram given in Figure 10.

Fig. 10. Oscillogram of RMS acceleration from the P3 measuring point.

Analyzing the results of vibration obtained in the 3 measuring points of the passenger vehicle, it follows that the acceleration is greatest at the P3 point, i.e. the front seat, along the vertical direction. Also acceleration values obtained for the first two measurement points are very close.
